Asset Inventory and Capital Improvements Plan

Town of Lake City

June 2, 2025

SCJ ALLIANCE
CONSULTING SERVICES

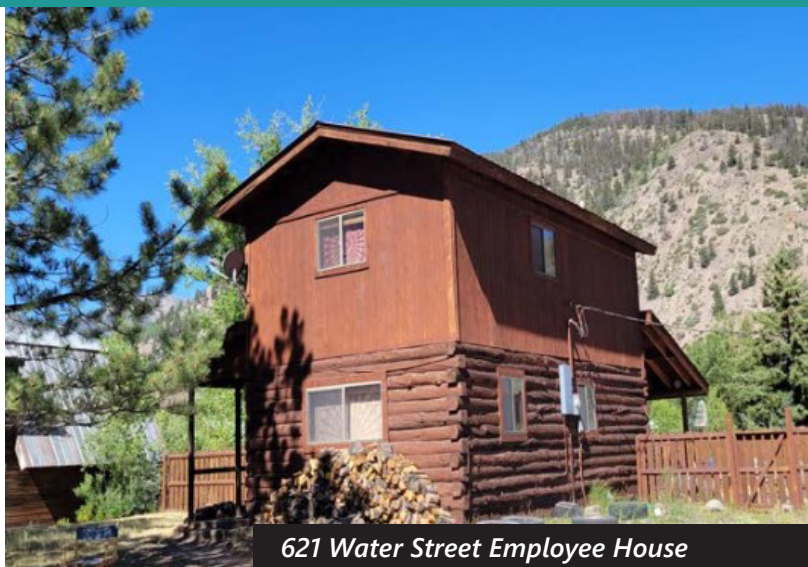
621 Water Street Employee House

The town owns a 1,170 SQFT property at 621 Water Street that is currently used as employee housing. The building structure is a two-story stick-built log cabin sitting on a cement foundation built in 1978. The building has wood floors and a metal roof, with its heating being provided by electric baseboard heaters and a wood burning stove. The building has had multiple improvements made to it in the last couple of years as noted in the maintenance schedule below. The building does not currently have ADA access into or through it.

ASSET	DIMENSIONS	DESCRIPTION	CONDITION
621 Water Street- Employee House	1,170 SQFT	2 story insulated log cabin house, second floor has wood siding, wood burning stove, electrical floorboard heaters, wood front porch, wood deck partially covered by metal roof	3-Fair

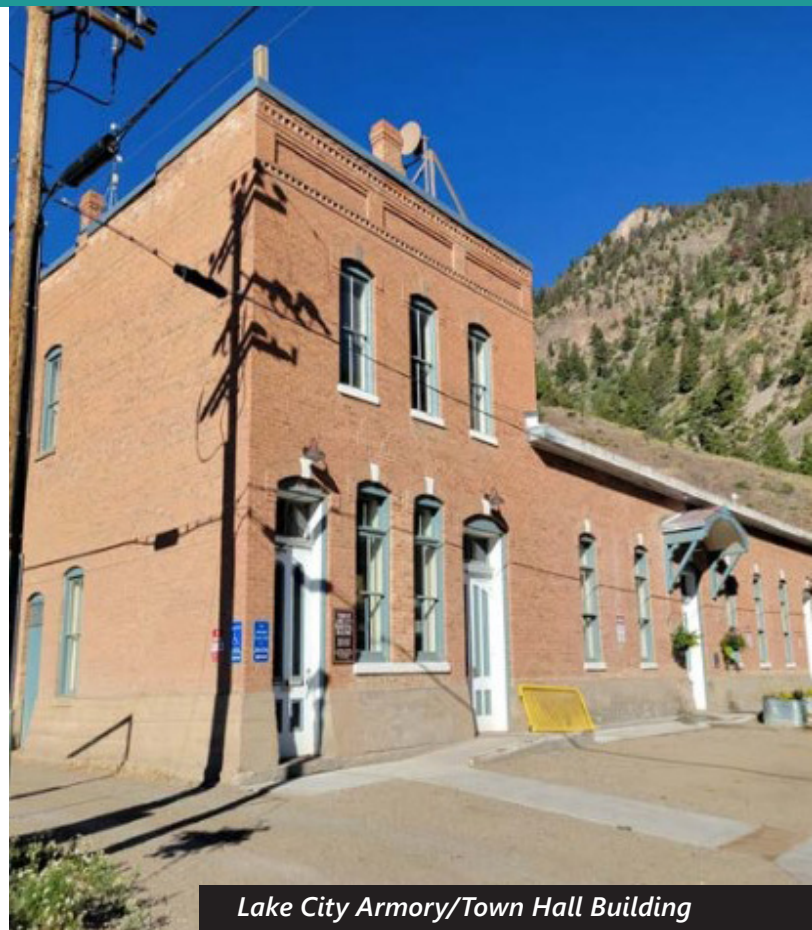
Lake City Armory/Town Hall Building

There was an addition added to the back of the main armory/gymnasium that included a multi-purpose meeting room, a commercial kitchen, new restrooms, a storage room, all of which is ADA accessible.

The recent renovation and expansion project improved the ADA accessibility of all rooms, except for the second-floor apartment, which remains accessible only via a flight of stairs at both the front and back entrances.

The renovation and expansion project of the Armory building in 2016 addressed many of the buildings' historic concerns and outdated utilities. However, there remain a few outstanding areas that were not addressed during that project. The asset inventory assessment identified the need for window replacements in both the Town Hall Office and the Fitness Center located within the Armory Building, but due to the historic nature of the windows they cannot be replaced. There is also a need for a fire suppression system for the Town Hall residential apartment.

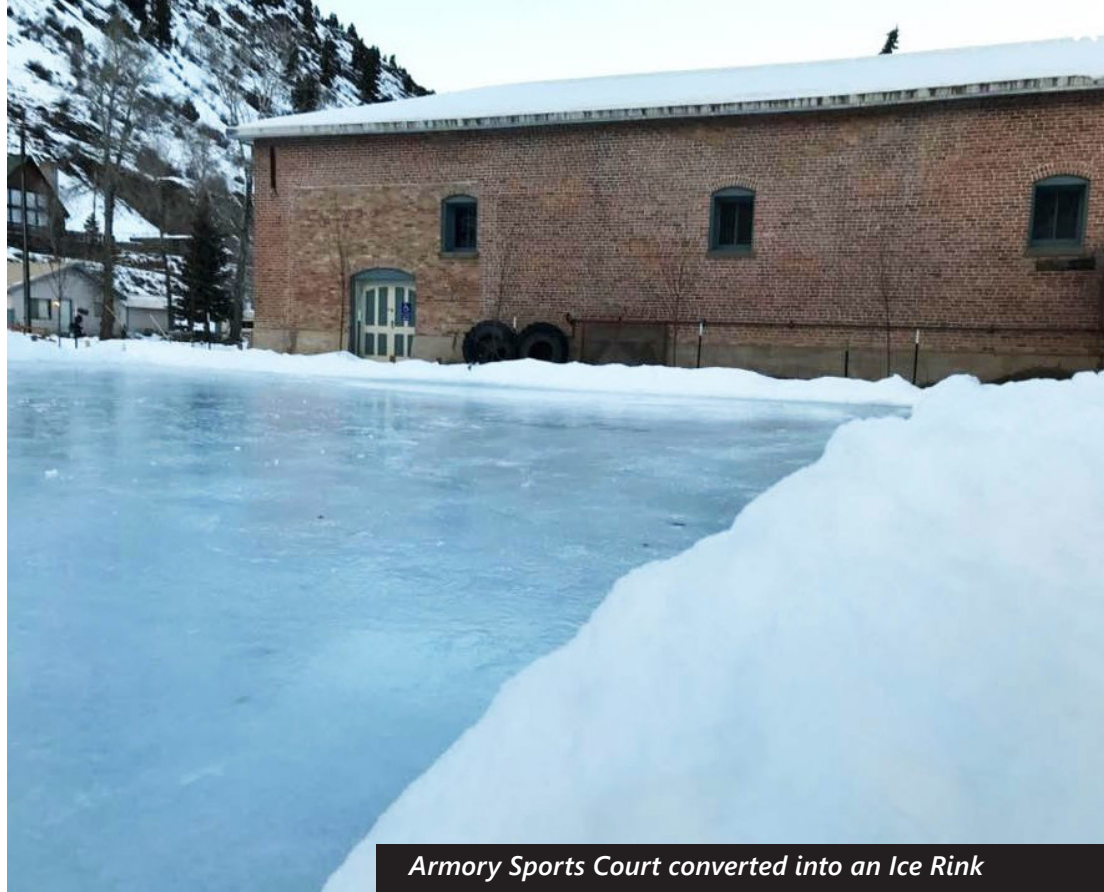
Armory Sports Court converted into an Ice Rink

A 3,000 SQ FT outdoor sports court provides a recreational surface in the summer and can be converted into an ice rink during the winter months. A 120 SQ FT shed on skids, built at the beginning of 2023, provides storage for recreation equipment.

ASSET	DIMENSIONS	DESCRIPTION	CONDITION
Armory - Outdoor Sports Court	3000 SQFT	Outdoor sports court	4 - Good
Armory - Storage Shed	120 SQFT	T1-11 plywood shed to store recreation equipment	4 - Good
Armory - Building/Town Hall Office & Apartment	10,420 SQFT	Brick walls/Membrane, metal, and other roof/hardwood floors/Ceiling wood beams/drywall in office/apartment plaster and drywall, gym drywall, concrete block, and brick walls	4 - Good
Armory - Fitness Center	900 SQFT	Weightroom/fitness center	4 - Good
Armory – Multi-Purpose Room	600 SQFT	Room with food service door to kitchen, 600 sq feet	4 - Good
Armory-Kitchen	400 SQFT	Commercial kitchen with 4 sinks, large double propane oven with top and burners, hood vent with fire suppression, fridge, freezer, ice maker, dishwasher	4 - Good
Armory - Underground Propane Tank	-	1000-gallon AmeriGas propane tank	4 - Good
Town Hall/Armory - Generator	-	125kW generator, green weatherproof aluminum enclosure	4 - Good

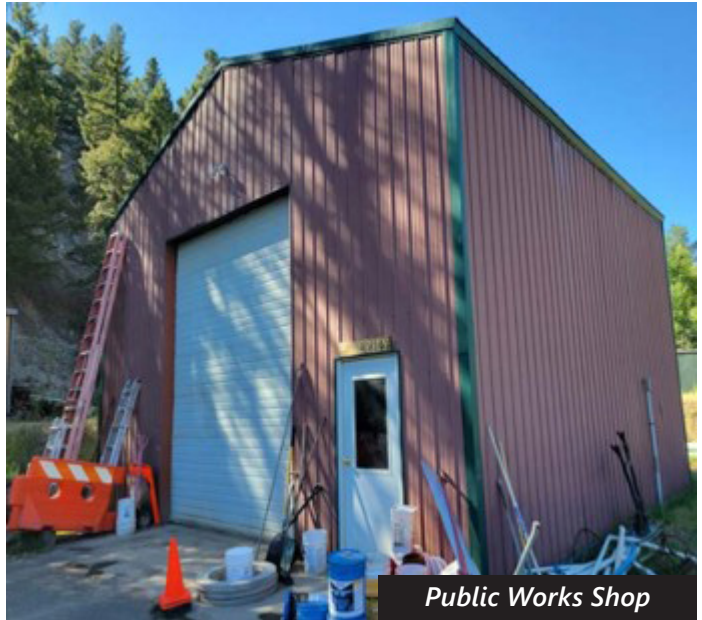
The Public Works shop is a single-story sheet metal building located at 1000 Hotchkiss Street. It serves as a storage facility and mechanical workshop for the public works department. The pre-engineered building has a concrete foundation and floor with uninsulated metal walls. It has fluorescent lighting and is heated by a propane heater.

ASSET	DIMENSIONS	DESCRIPTION	CONDITION
Public Works Shop and Garage	900 SQFT	Metal Walls/Metal Roof/Concrete Flooring	3-Fair

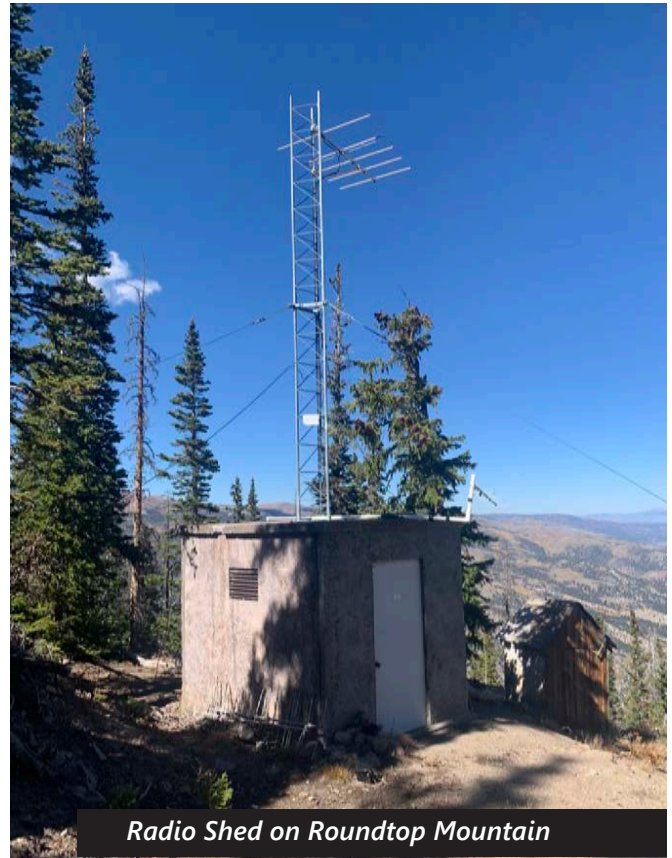
Radio Shed on Roundtop Mountain

A condition assessment was conducted of the Roundtop Communications Facilities and the corresponding assets associated with it. The additional assets are listed below, with an average rating for all condition fields to indicate the overall status of each asset. A detailed breakdown of the full asset inventory condition is provided in “Appendix B: Asset Inventory Spreadsheet” Any assets with a condition rating equal to or less than 2 (Poor) will include a discussion of potential correctional measures to address the condition.

One area that will need to be addressed in the CIP and budgeted accordingly is the replacement of the electric system inside of the battery shed. The electric system was deemed to be in poor condition during the asset inventory performed in October of 2024. A plan for improvement and funding is outlined in the CIP chapter of this report and also addresses the additional improvements discussed in the Round Top Communications Center Report prepared by Rolf Gloeckner.

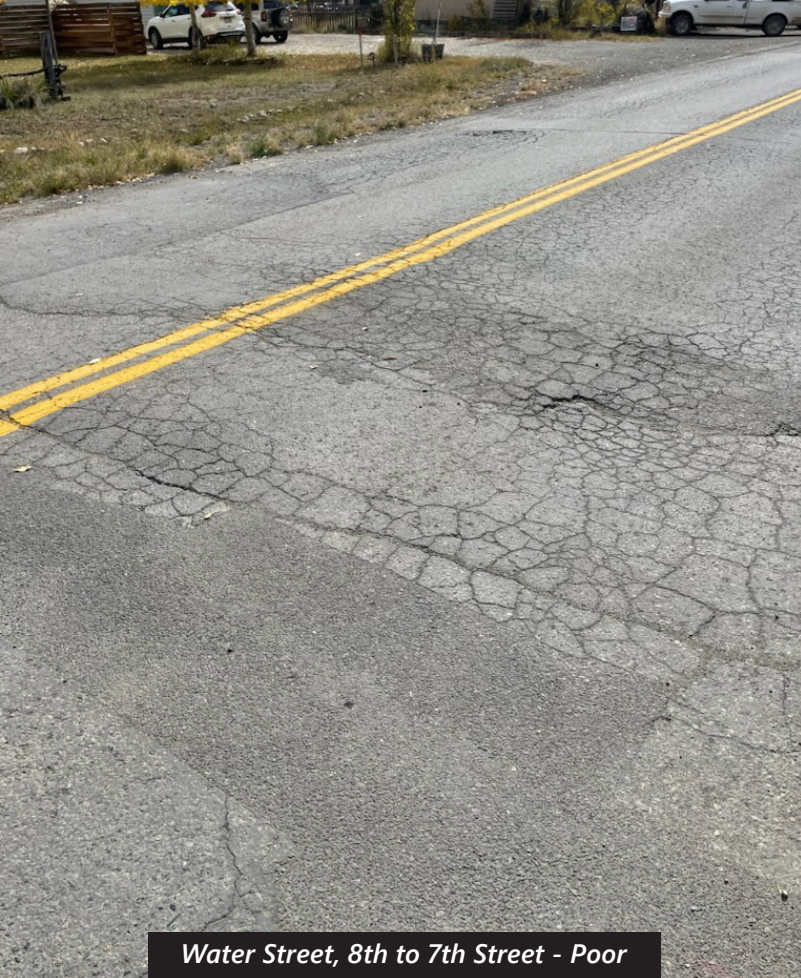
Water Street, 8th to 7th Street - Poor

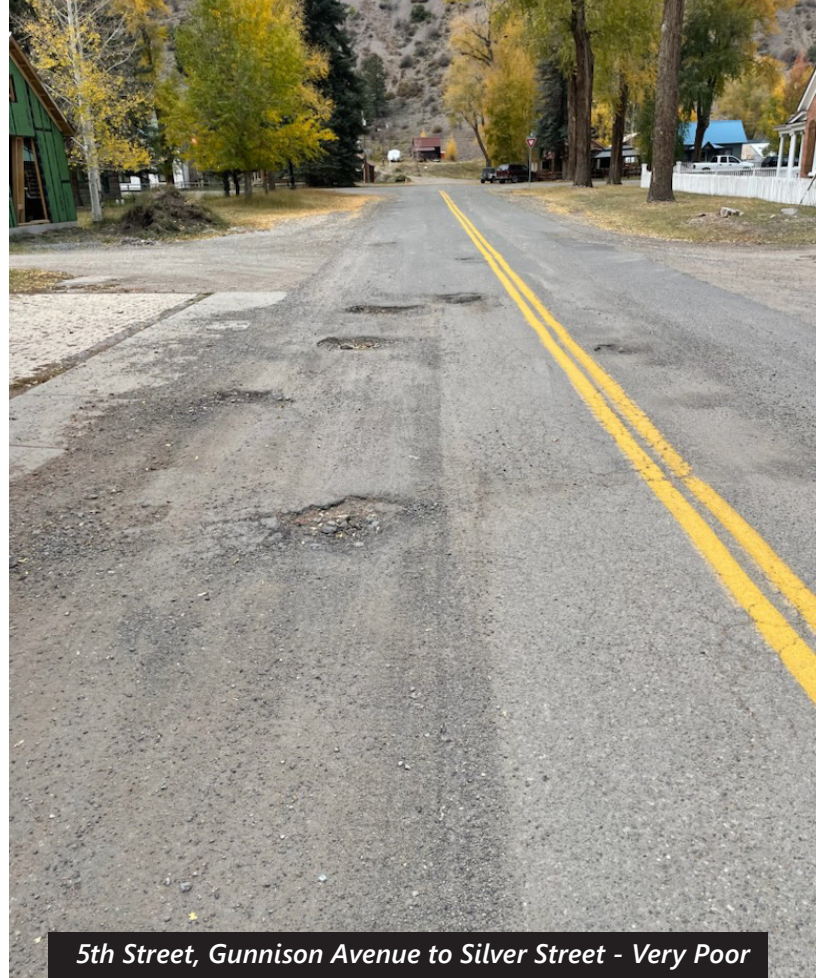
5th Street, Gunnison Avenue to Silver Street - Very Poor

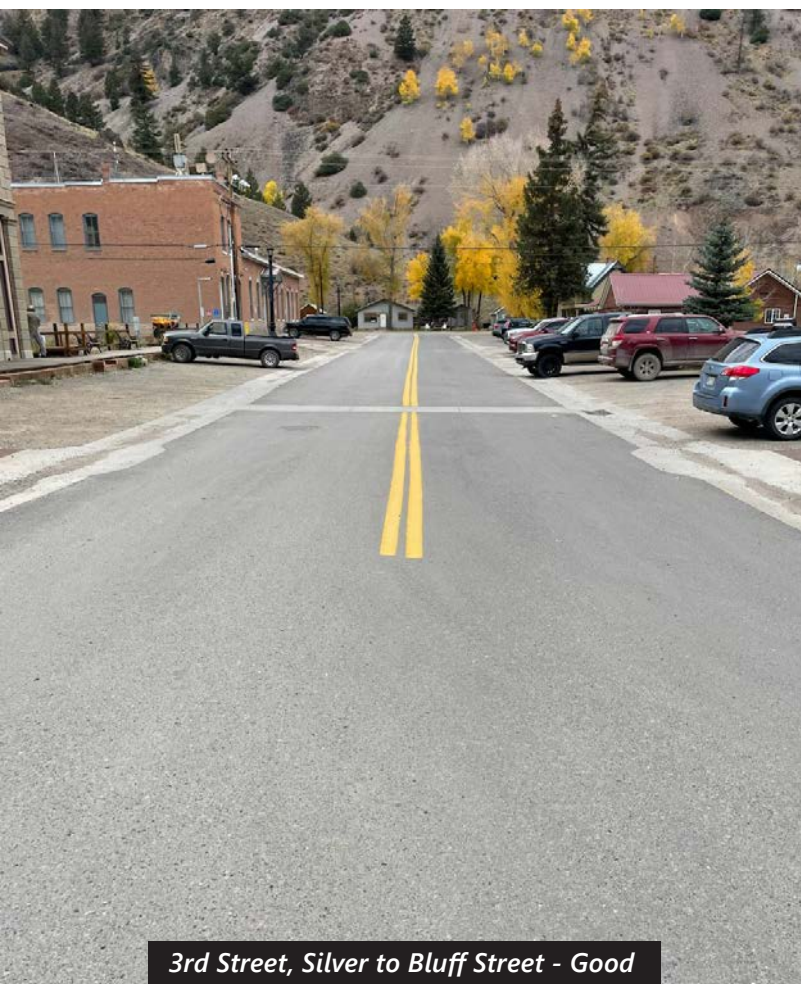
3rd Street, Silver to Bluff Street - Good

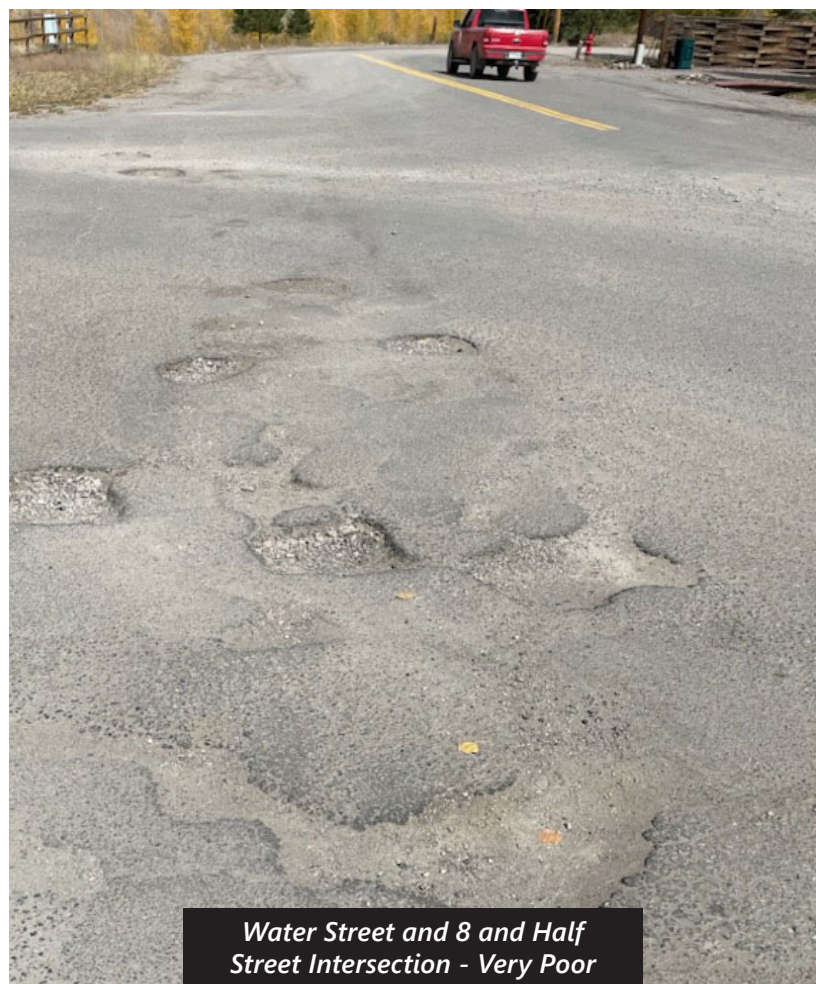
Water Street and 8 and Half Street Intersection - Very Poor

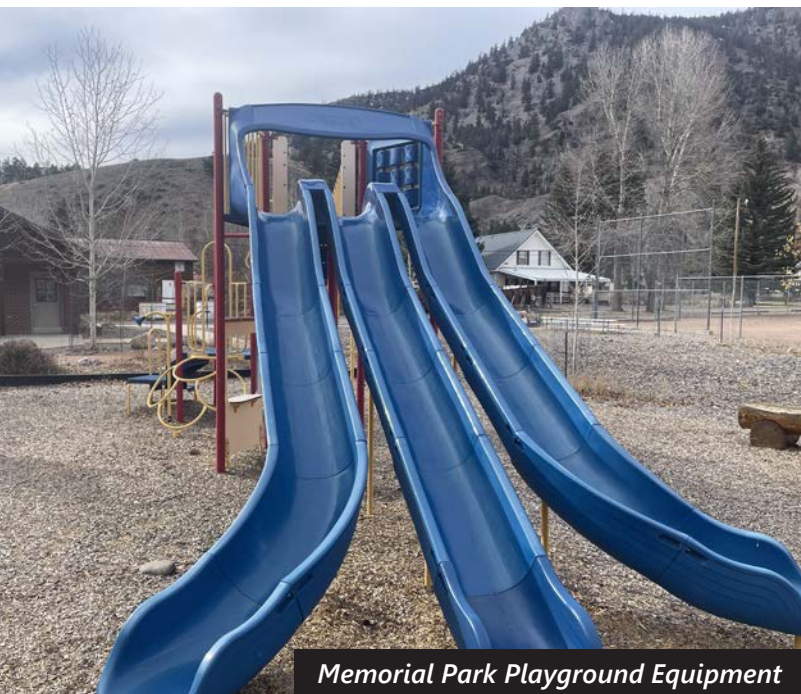
Memorial Park Playground Equipment

The asset inventory assessment identified the need to replace the boards on both the Memorial Park Pedestrian Bridge and the Fifth Street Pedestrian Bridge in the short term. Looking at the replacement schedule also highlighted the need to consider the eventual replacement of the Memorial Park playground equipment. The playground equipment is still considered in “good” condition but has fulfilled its prescribed useful life in 2021.

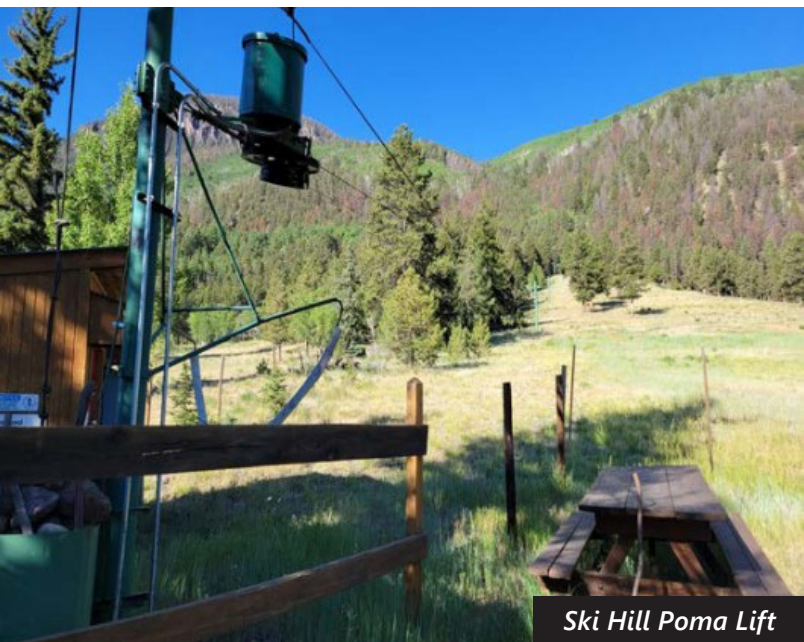
Ski Hill Poma Lift

Table 15. Ski Hill/Roundtop Mountain Park Asset Conditions			
ASSET	DIMENSIONS	DESCRIPTION	CONDITION
POMA Lift	990 FT	Cable Surface ski lift. Poles and platter that you sit on with two giant bull wheels, the biggest of which is on a tower at the top of the ski hill, and 3 lift towers.	3 - Fair
Warming Hut	450 SQFT	450 sq foot stick-built building with plywood walls, no interior finishes, and board floors. The building has a wood burning stove in the center for heat.	2 - Poor
Operator Shack	18 SQFT	18 sq foot stick-built building with plywood floors housing controls and tools for the ski lift.	4 - Good

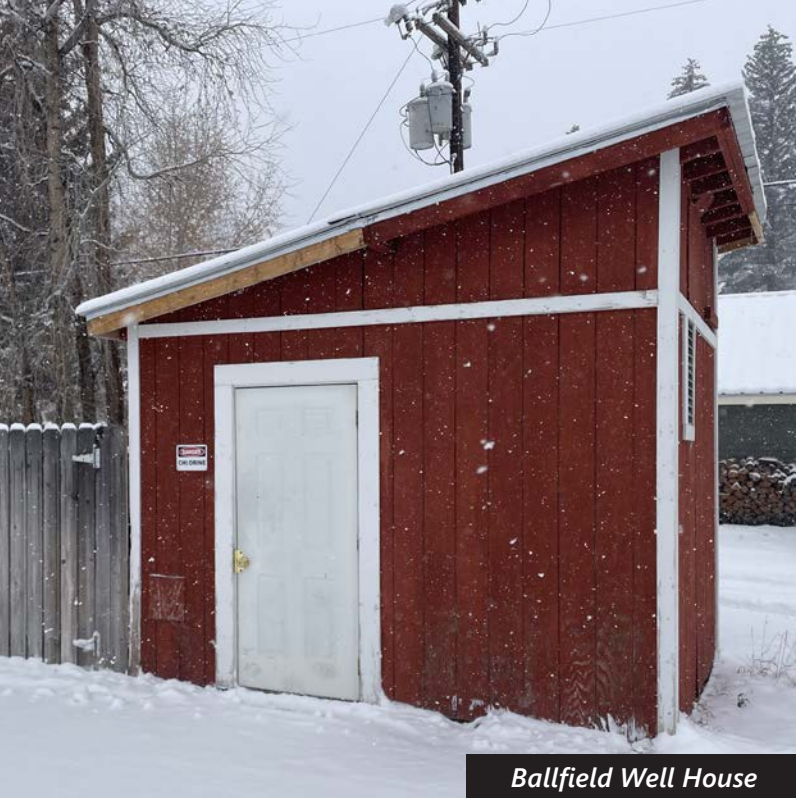
Ballfield Well House

The water treatment systems at Bluff Street and the Ballfield are comprised of well pumps and treatment equipment located in stick-built sheds. The water is pumped into the two well houses where it is chlorinated using sodium hypochlorite, and a corrosion inhibitor (poly orthophosphate) is then added. The water from the Bluff Street well will then enter into the chlorine contact chamber along 1st street. Once the water has sufficient contact time it is pumped to the tanks for storage. That process creates the pressure needed for the distribution system.
